A BRAND NEW SHOWER?

By Ted Kellogg Style Tile 936.344 TILE (8453)

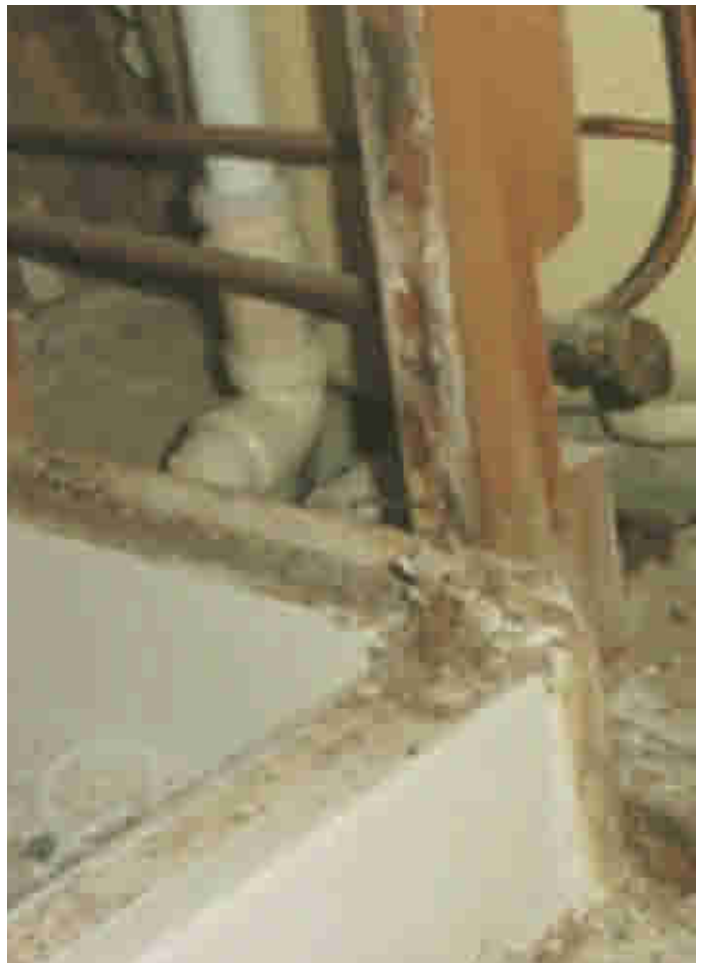
(Above) Further removal of the greenrock exposes the deterioration of the wood framing members. This damage is caused from getting wet and drying out repeatedly.

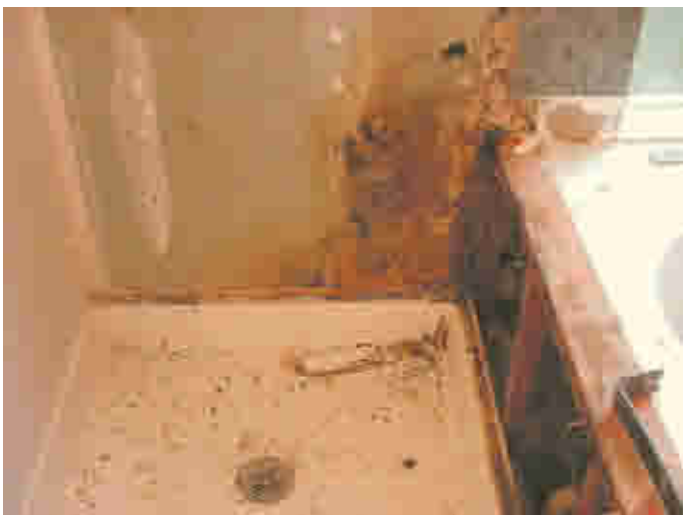
.....far from it! This shower area is approximately six years old, and as evidenced by the picture has been well taken care of, and certainly qualifies as “good housekeeping.”

This homeowner was, as any other day, in the closet preparing to leave for work, and noticed moisture on the carpet. Unsure whether this moisture was a result of a leak in the wall, the roof, or a failed shower pan, decided to immediately call and have the pan tested. Interestingly, the shower pan passed the test, however, upon further examination we noticed discoloration of the wall, and eventually the leakage.

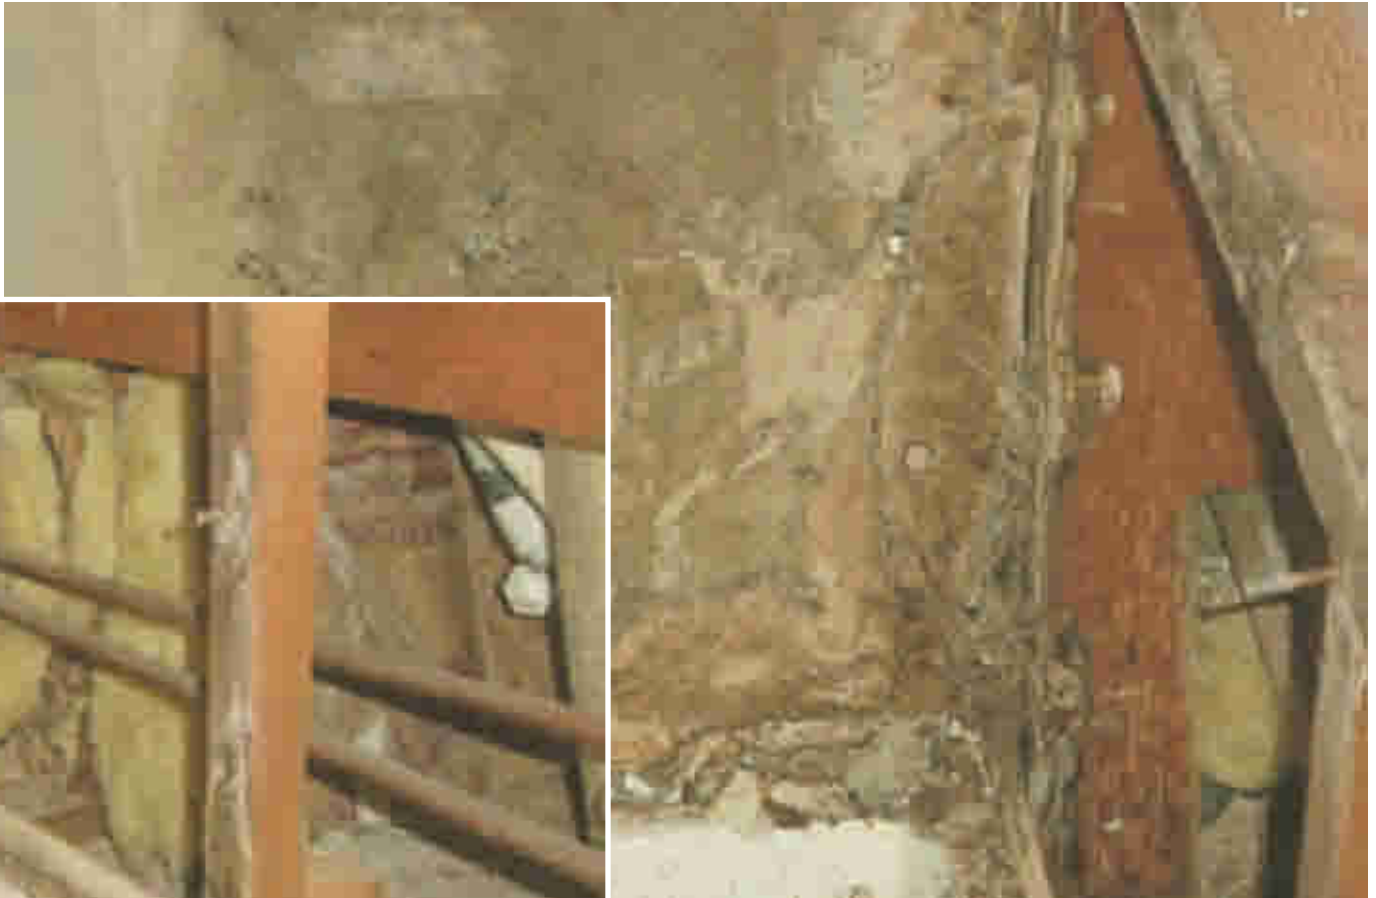
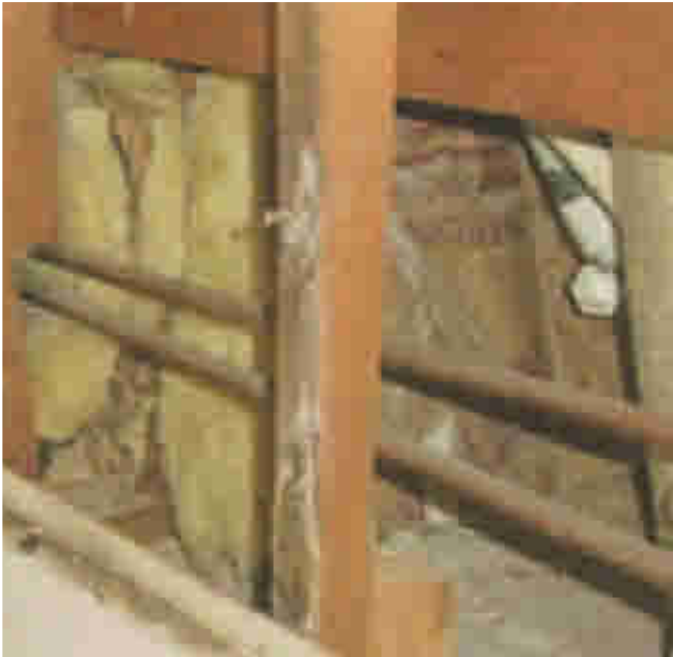
(Above) Additional close up damage mold can cause when moisture wicks behind the shower walls.
